# V12 and probably V9-V10 DEAD BEEF SYNDROME

v.0.95

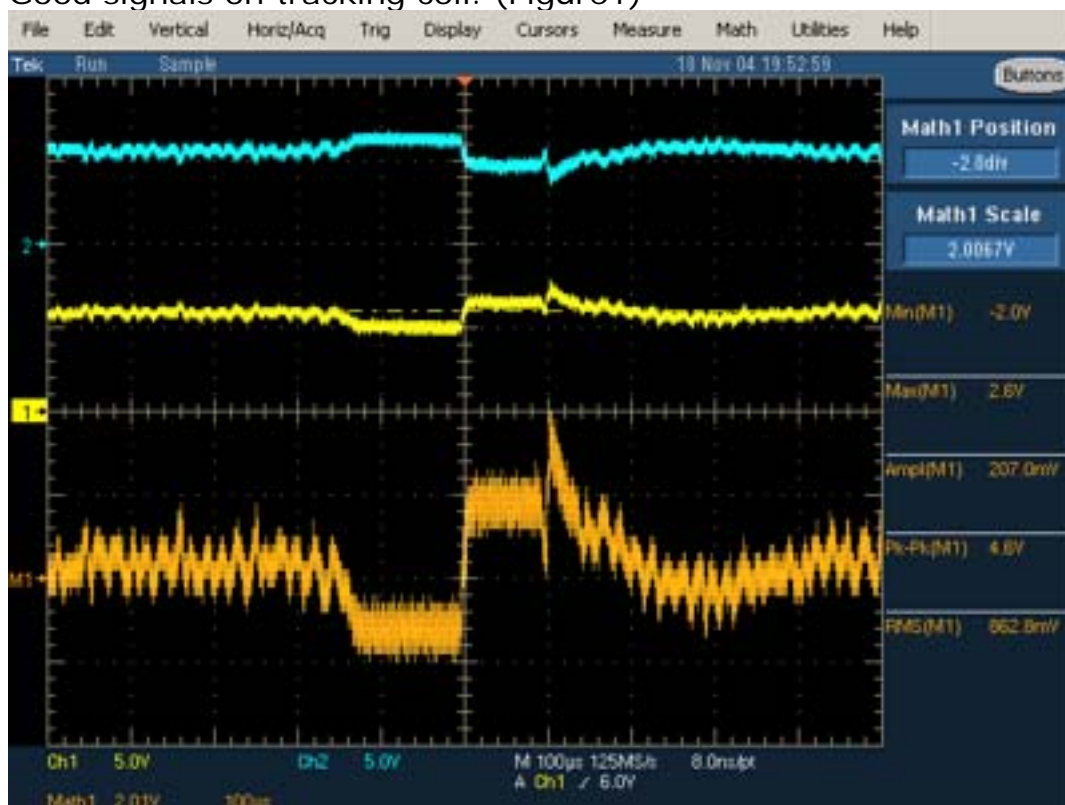
Good signals on tracking coil. (Figure1)

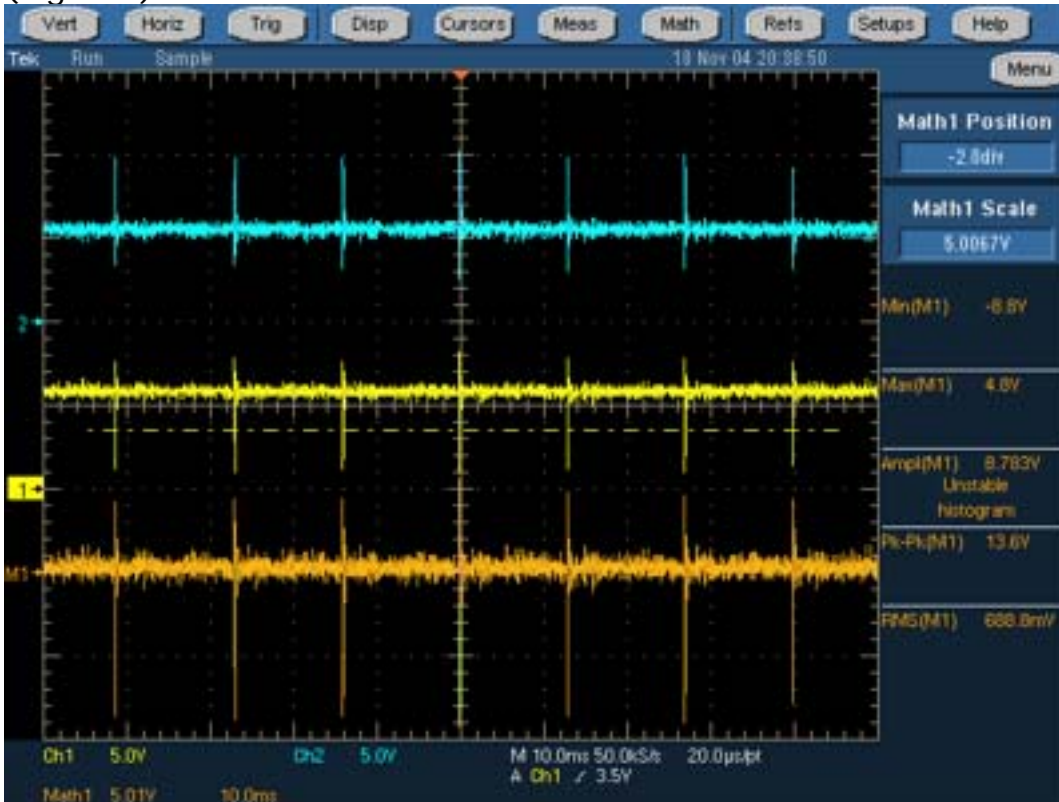
(Figure4)

This image illustrates the same pulses on focus coil but it is presented at slower time base of the scope.

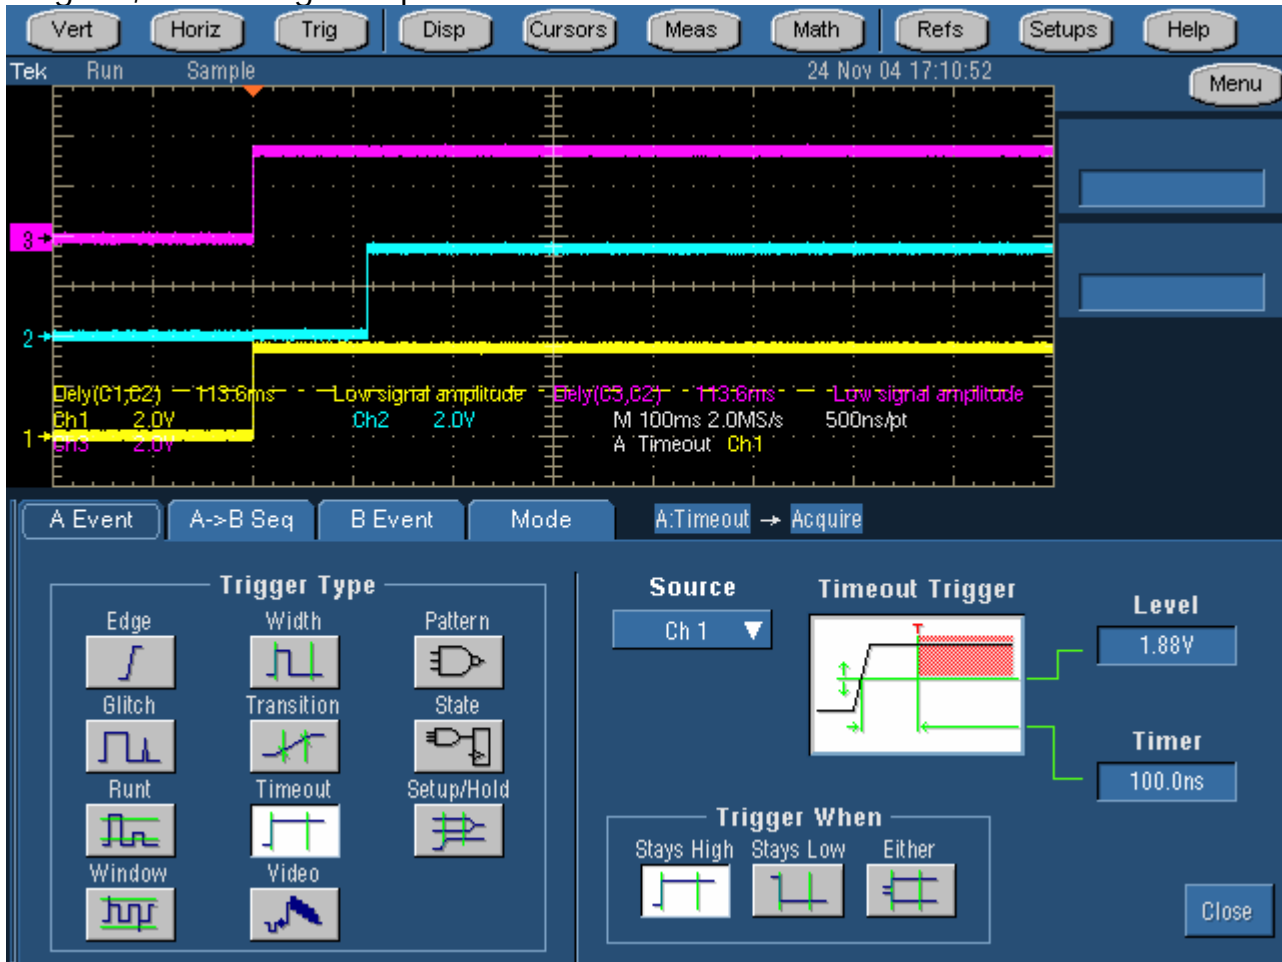
CH1 is INPUT Voltage, CH2 is RESET output, CH3 is OUTPUT Voltage  
Original, not changed cap value.

Original, not changed cap value.

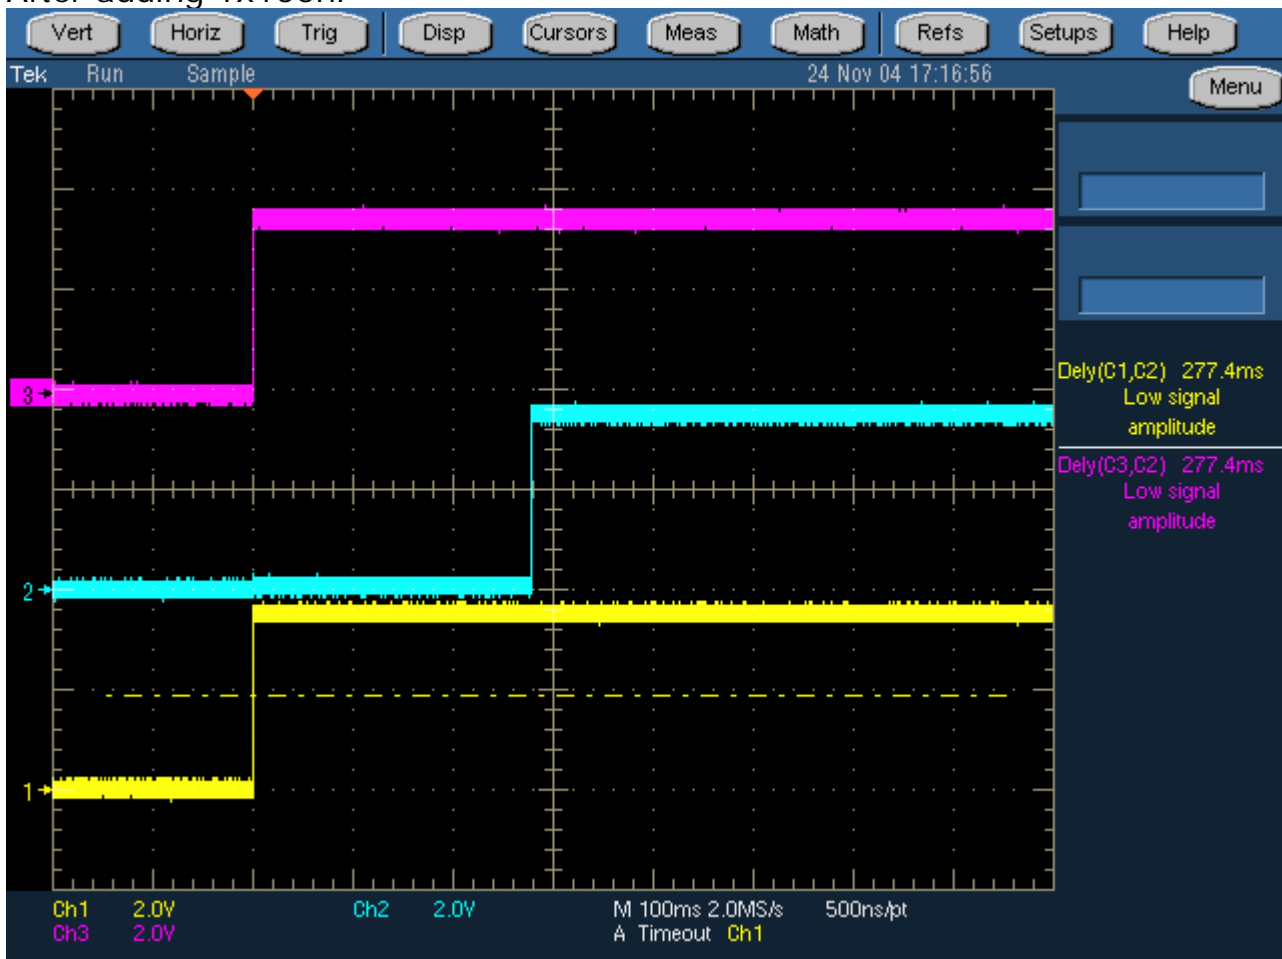
After adding 1x100nF

The idea is to extend the RESET time of the Mechacon during the time you are manipulating with the power plug. You will notice that the red light will appear around 1 second later then before adding 470n. It is very good. Remember to filter power replacing 0 ohm by inductor. Add tantalum cap somewhere close to the regulator and you can add some 100n caps somewhere around but for decoupling use Z5U dielectric because it has lower ESR then X7R.
